Manhole Inspection Summary

Manhole # S19QQ_001MH

Insp Date: **7/10/07 9:17 AM**

Location Address: **1700 WOODBROOK AVE**

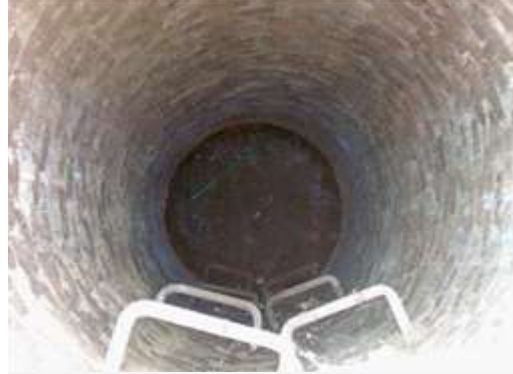
Top View

DEBRIS ON BENCH

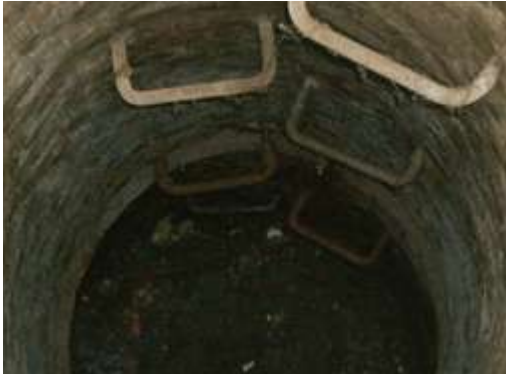
Defect 2

Count: **9** Missing: **0** ☒ **Corroded**

CORRODED STEPS

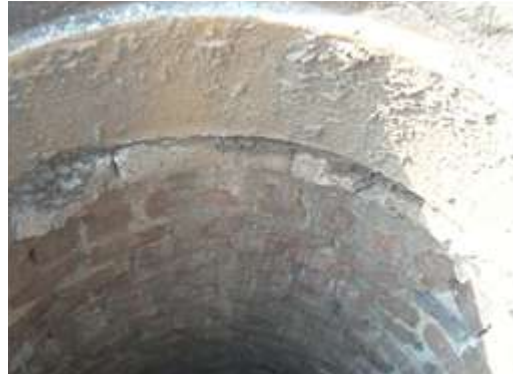
Defect 1

Condition: ☐ Sound ☐ Cracked ☐ Root Intrusion ☐ Loose Brick ☒ **Deteriorated**

DETERIORATED CHIMNEY

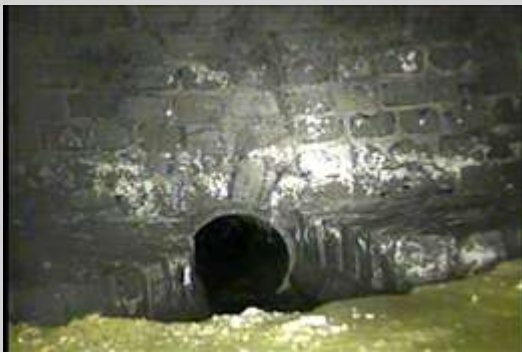
12 O'Clock Outflow

Pipe Height: **7.2** (in.) Rod and Bar (Angled)
Pipe Material: **Clay** ☐ Pipe Lined
Invert Depth: **15.89** (ft.) Flow Characteristics: **Slow**
Deposits: ☒ None ☐ Mud ☐ Sludge ☐ Debris ☐ Grease
Silt Depth: (in.) Deposits Extent:
Infiltration: **None** Pipe Seal Cond: **Sound**

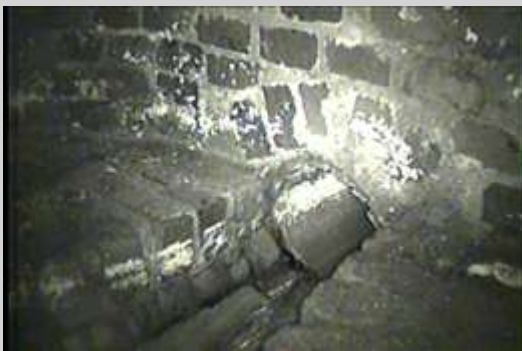
3 O'Clock Inflow

DEBRIS ON BENCH

Pipe Height: **8.4** (in.) Rod and Bar (Angled)
Pipe Material: **Clay** ☐ Pipe Lined
Invert Depth: **15.83** (ft.) Flow Characteristics: **Slow**
Deposits: ☐ None ☐ Mud ☐ Sludge ☒ **Debris** ☐ Grease
Silt Depth: **7** (in.) Deposits Extent: **Heavy**
Infiltration: **None** Pipe Seal Cond: **Sound**

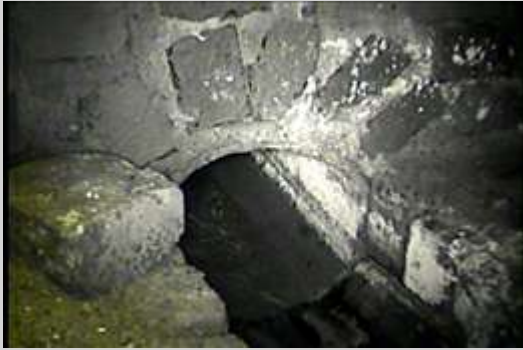
9 O'Clock Inflow

Pipe Height: **8.4** (in.) Rod and Bar (Angled)

Deposits: ☒ None ☐ Mud ☐ Sludge ☐ Debris ☐ Grease

Infiltration: **None** Pipe Seal Cond: **Sound**
